Army Lodging Wellness Recommendation

Fort Belvoir - Final Submittal

August 13, 2003

3D/I

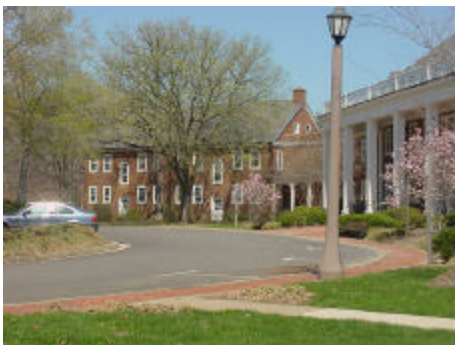
Lodging Building 20B

Building 20B, constructed in 1974, is connected directly to the Officer's Club. This building has been recently renovated and now serves as DVQ's for visiting officers. The north wing houses 4 one-bedroom guest rooms, and the south wing houses 8 one-bedroom guest rooms. These facilities are in excellent condition and meet current Lodging standards as family rooms.

Our recommendation is to retain building 20B within the Fort Belvoir Lodging inventory. This facility will remain in the Fort Belvoir Wellness Solution Lodging Master Plan.

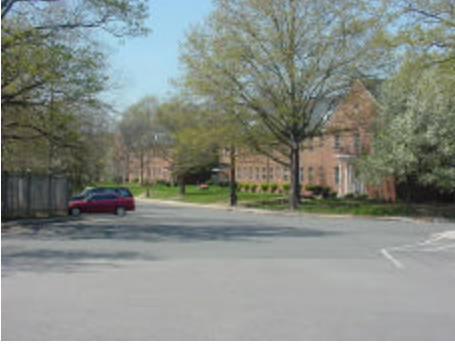
Lodging Buildings 80 and 81

Buildings 80 and 81, constructed in 1948, have been upgraded and renovated in recent years. The two 2-story buildings are mirror images of each other and contain 47 rooms. Building 80 has 44 rooms functioning as standard room, and building 81 has 45 rooms functioning as standard rooms, each with shared baths. Both of these buildings are in poor condition and do not meet current Lodging standards. The cost to make condition assessment improvements will exceed the 50% replacement cost.

Our recommendation is to remove these buildings from the Lodging inventory, allowing the installation to determine an alternate use for the facilities. These facilities will be removed from the Fort Belvoir Wellness Solution and Lodging Master Plan.

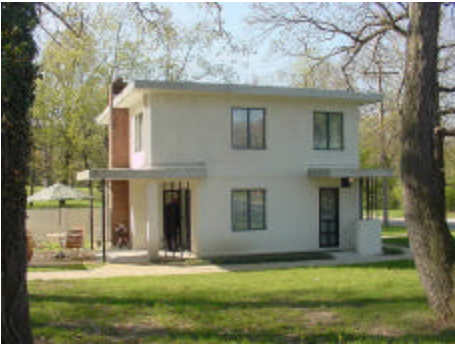
Lodging Building 172

Building 172, constructed in the 1950's, received a major renovation in 2000. This building presently has one bedroom and serves as a DVQ. The building is in good condition but does not currently meet the Army Lodging standards. The cost to make improvements and to bring the facility up to Army Lodging standards will exceed the 50% replacement cost.

Our recommendation is to remove this building from the Lodging inventory, allowing the installation to determine an alternate use for this facility. This facility will be removed from the Fort Belvoir Wellness Solution and Lodging Master Plan.

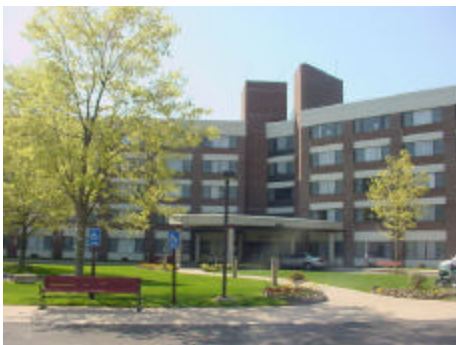
Lodging Building 470

Building 470, Knadle Hall, constructed in 1975, currently houses 219 extended stay rooms, six of which are used as DVQ's. The building has two 5-story wings and serves as the primary lodging facility.

This building infrastructure is to be used over the next 15-20 years with normal maintenance, and renovated based on condition and functional requirements. Based on age of the structure, however, we do not recommend significant renovations to the public spaces and/or back-of-house space to meet functional criteria. These support spaces will instead be reconfigured to meet secondary facility functional requirements.

Our recommendation is to retain building 470 in the Fort Belvoir Lodging inventory. This facility will remain in the Fort Belvoir Wellness Solution and Lodging Master Plan.

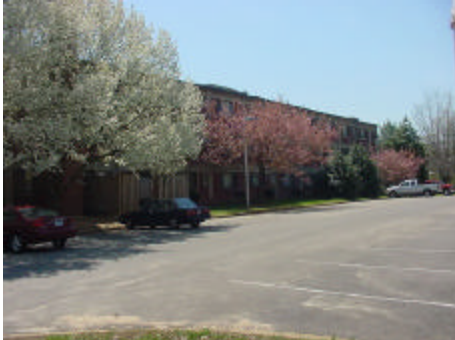
Lodging Building 505 and 506

Buildings 505 and 506, constructed in 1956, are similar. Building 505 includes 45 rooms consisting of 32 one-bedroom guest rooms with shared baths and 13 two-bedroom, one bath guest rooms. Building 506 houses 60 rooms of which 29 are guest rooms comprised of two-bedroom, one bath rooms.

These buildings are in fair condition but do not meet the Lodging size requirements. The cost to modify to meet Army Lodging standards will exceed the 50% replacement cost.

Our recommendation is to remove these buildings from the Lodging inventory, allowing the installation to determine an alternate use for the facilities. These facilities will be removed from the Fort Belvoir Wellness Solution and Lodging Master Plan.

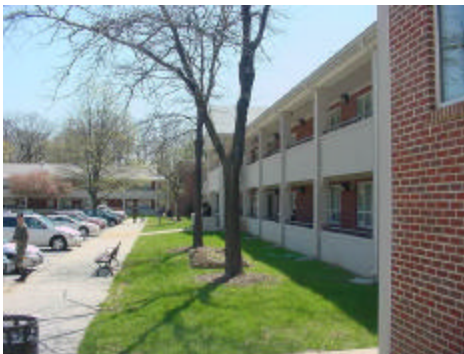
Lodging Buildings 507, 508 and 509

Buildings 507, 508 and 509, constructed in 1969, are 2-story facilities, similar in construction and appearance, and have recently been renovated. Buildings 507 and 508 each consist of 42 rooms comprised of 38 extended stay rooms and 4 family suites. Building 509 consists of 32 extended stay rooms and 3 family suites. All three of these buildings are in good condition and meet the Lodging size requirements. The buildings are lacking some of the back-of-the-house and public functions. These areas are incorporated into the renovations plans.

Our recommendation is to retain buildings 507, 508, and 509 in the Fort Belvoir Lodging inventory. These facilities will remain in the Fort Belvoir Wellness Solution and Lodging Master Plan.

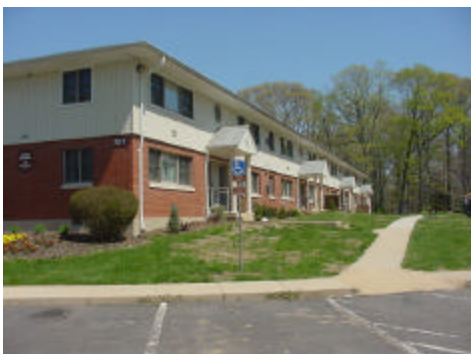
Lodging Buildings 806 and 807

Buildings 806 and 807, constructed in the 1960's, have been recently renovated. Building 806 is a 2-story building with 9 two-bedroom rooms with one bath and kitchen. Building 807 is a similar two-story building with 12 two-bedroom guest rooms and 4 one-bedroom guest rooms, each with one bath and kitchen. Both of these buildings are in good condition but do not meet current Lodging standards. The cost to make improvements and to bring up to Army Lodging standards will exceed the 50% replacement cost.

Our recommendation is to remove these buildings from the Lodging inventory, allowing the installation to determine an alternate use for the facilities. These facilities will be removed from the Fort Belvoir Wellness Solution and Lodging Master Plan.

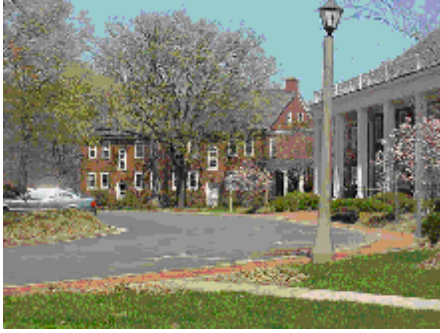
The renovation plan was not required because existing spaces meet current size requirements and the current building is in good condition to meet lodging requirements.

Because the Condition Assessment to Replacement Cost Ratio is less than 50%, repair and continued use of Building 20B is recommended.

- Analysis: The structural foundation, given its proximity to the Potomac River, is probably on driven piles with pile caps. The structure is one of reinforced concrete of beam and post design with concrete floors. No visible flaws were observed.
- Recommendation: No corrective action required.

- Analysis: The slab on grade appears to be in good condition with no visible signs of failure.
- Recommendation: No corrective action required.

- Analysis: The elevated floors are reinforced concrete in good condition.
- Recommendation: No corrective action required.

- Analysis: The roof construction is one of sloped slate roof on a wood substrate. The roof is an original system that was installed when the club was constructed. The slate roofs have an extended life span. This roof is in good condition.
- Recommendation: No corrective action required.

- Analysis: The exterior of Building 020 B is brick which is in good condition.
- Recommendation: No corrective action required.

- Analysis: The FF&E within the suites are in fair condition.
- Recommendation: Replace the FF&E.
